## ANALYSIS OF STEEL TANKS IN CHILE SUBDUCTION EARTHQUAKES

### **Abstract**

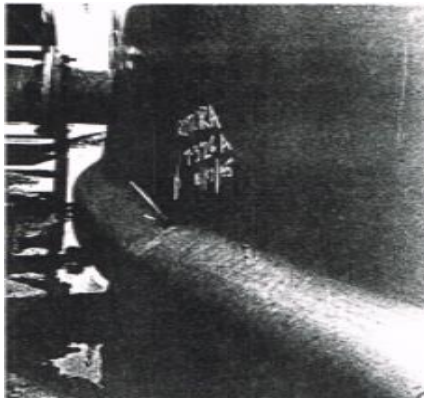
Figure 5. Algarrobo, Chile 1985 earthquake, buckling shell, Oil refinery. Buckling of Shell foot elephant.

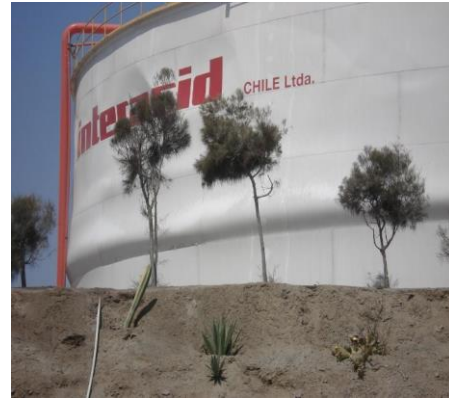
Figure 6. Tocopilla, Chile 2007 earthquake, sulfuric acid plant. Buckling of shell.

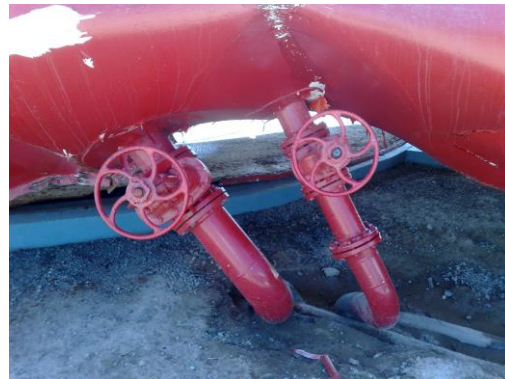
Figure 8. El Maule 2010, Chile earthquake. Large deformations of water pipes connected to shell tank, Santiago Airport.

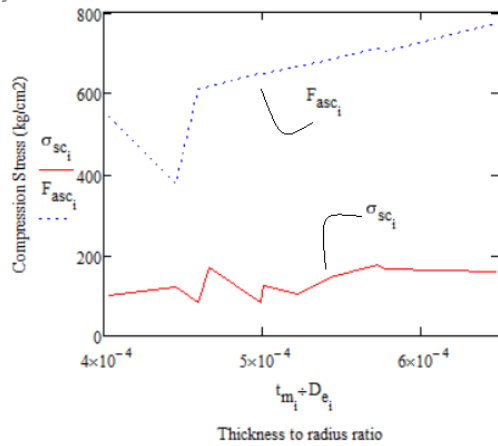
Figure 11. Tank performance in 1985 Chile earthquake for shell compression, showing that allowable stress is 13 to 20% of estimated shell compression despite the observed buckling of shell.  $\sigma_{sc}$  (calculated),  $F_{asc}$  (allowable), both in  $\text{kg}/\text{cm}^2$ .

According to results of Backward Analysis (Figure 11), the allowable stresses calculated by the API650-E standard used in the design of tanks observed in the Chile earthquake of 1985 are considerably lower than stresses of shell compressions, which results in an underestimation of the requirements of this standard design.

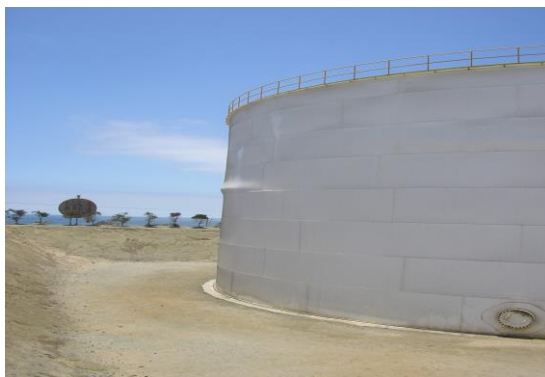
Figure 15. Tocopilla, Chile 2007 earthquake, sulfuric acid plant. Failure in the earthquake directivity.

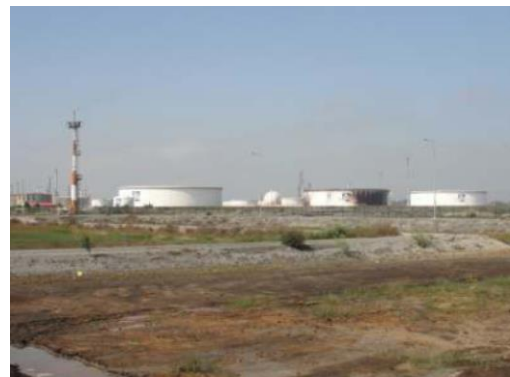
It should be noted that displacement registers shown by displacement spectra in Figure 14 refer to vibratory motions, whereas the formula (1) and the sloshing of Figure 16 shows an inertial behavior in the mentioned coseismic direction. Considering this formula, anchors of tanks will be required in some cases despite API 650-E recommendation in order to avoid damage in bottom plates as well as piping, in addition to reducing the risk of buckling of shell. The sliding also produce seismic forces not consider in API650-E and other design codes for unanchored tanks. It must keep in mind that the small sliding has produced failure in bottom plates. Table 3 indicate sliding (S) of tanks in coast areas of subduction earthquakes. In 2007 Tocopilla Chile earthquake, the tank located on acid plant in Mejillones city, was detected a horizontal sliding between 80 to 100mm in the perpendicular direction of the coast and corresponding to convergence direction of subducted Nazca plate. According to the orientation the tank indicated in Figure 15 in perpendicular direction to the coastline besides the buckling of shell showing in Figure 6, explains the influence of the earthquake directivity. For the 2010 Chile earthquake Figure 10 shows that the tanks are oriented in direction N-S, on the other hand, Figure 16 shows that the central tank had slosh in W-E direction perpendicular to the coastline, similar to the above mentioned case for the earthquake 2007, confirming the influence of the coseismic directivity of the subductive Chilean earthquake. This effect is incident on the seismic response of tanks with a predominant the convective mass. In both cases the tanks were self-anchored, so it is important to consider a possible horizontal sliding in future earthquakes for tanks located in subductive zones near of asperities and assess the application of the equation (1). Figure 17 shows some tanks located in a gas plant in San Vicente port, tank on the west side on Figure 18 had an inclination of a one-degree perpendicular to the coastline, confirming once again that Chilean coast earthquakes dominated the directivity in the direction of subduction. The tank was built in 1968, it had height dimensions of 11.6m in diameter and 12 meters, and was full during the 2010 Chile earthquake.

Figure 16. El Maule, Chile 2010 earthquake, ENAP Bio Bio Refinery. Earthquake directivity.

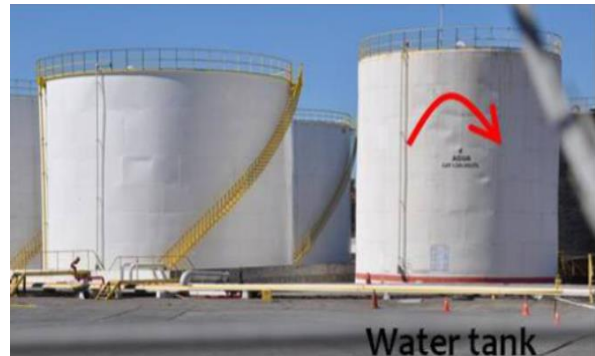
Figure 18. Tilted water tank at gas facility in the 2010 Chile earthquake.

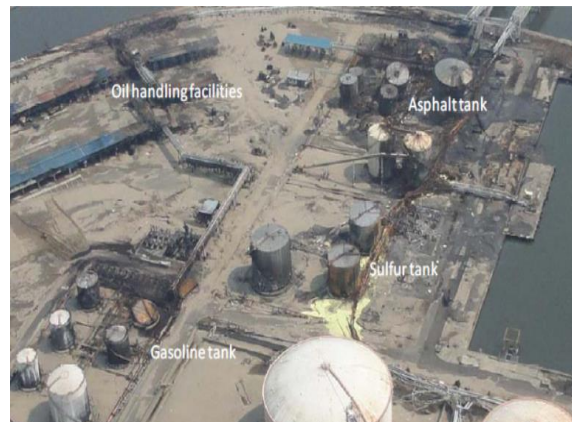
Figure 20. Burned-out zone refinery, 2011 Japan Earthquake [27].
