BACKWARD SEISMIC ANALYSIS OF STEEL TANKS

Patricio A. Pineda* and G. Rodolfo Saragoni*

* University of Chile, Santiago, Chile
 e-mails: patricio.pineda@ing.uchile.cl, rsaragon@ing.uchile.cl

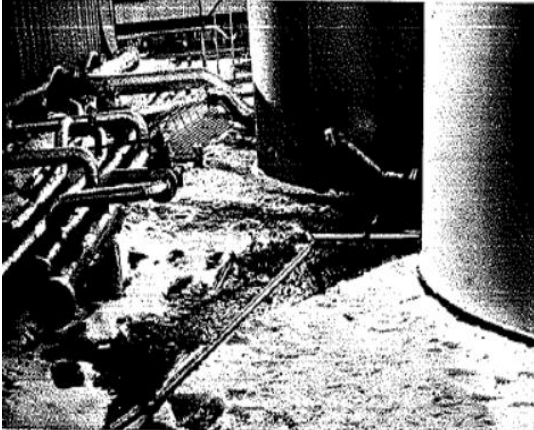
Rinne (1967) conducted the first backward analysis, with damaged tanks after the mega earthquake of Alaska 1964. In this first backward analysis, not difference between types of earthquakes it was considered. In this work being sorted according to these considerations, since it as will be shown below, most unanchored tanks failed and had large sliding in subduction earthquakes in coast areas. Cooper (1997) develop a backward analysis with information obtained from earthquakes of 1933 to 1995. As it was noted in STESSA 2012, Pineda and Saragoni (2012) concluded that in most earthquakes considered the common damage observed was buckling type "elephant foot" and horizontal sliding (Figure 1).

Figure 1. Horizontal sliding tank of 1524mm. 1964 Alaska earthquake. Rinne (1967).

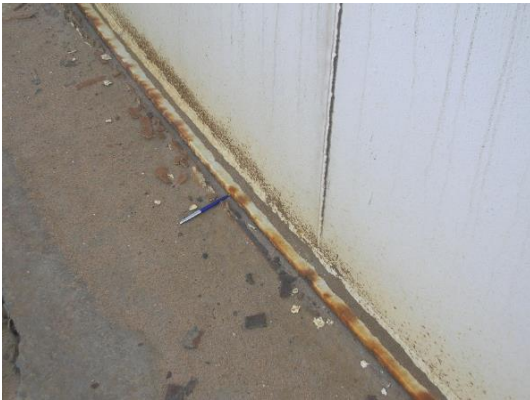
The Tocopilla earthquake occurred on November 14, 2007 was of magnitude 7.7. Near the epicentre area is located the tank TK-201 Interacid owned company located in Mejillones plant. In this plant, there are two steel tanks with similar characteristics, being one empty and one with liquid, information that was provide after the earthquake. The damaged tank is unanchored according to the requirements of API650-E. This tank has a diameter of 35m, height 14.5m and shell thicknesses varying between 8mm and 25mm. At the time of the earthquake, it was partially fill with acid with specific gravity 1.83ton/m³, reaching a liquid level of about 9.1m at the time of the earthquake, with a freeboard of 314cm. The maximum horizontal accelerations recorded on the ground of 0.42g and 0.41g in Mejillones and Tocopilla. The maximum vertical accelerations recorded on ground of 0.36g and 0.27g in Mejillones and Tocopilla city. Under the foundations of the tanks are bad graduate burdensome sandy soils and sands with few fines. Tank TK-201 presented effect of earthquake damage such as buckling type “elephant foot” at the top of the shell and lifting of the base with permanent deformation of 70 to 80mm. Horizontal sliding was observed from 80 to 100mm in the perpendicular direction to the coast and corresponding to the convergence direction of the subducted Nazca plate (Figure 3). The bottom plate of the tank was wrinkled by the horizontal displacement. In Figure 4 are shown two plate asperities due to Tocopilla 2007 earthquake ((Peyrat et al. (2009)) showing displacement larger than 1.5 meters in Tocopilla zone, similar to 1985 Central Chile earthquake. The tank TK-201 was located at the south asperity near Mejillones, suffering horizontal displacement, which in larger magnitude earthquake could be about 1 meter.

Figure 3. Horizontal sliding (80mm) Tank TK-201. 2007 Tocopilla earthquake.

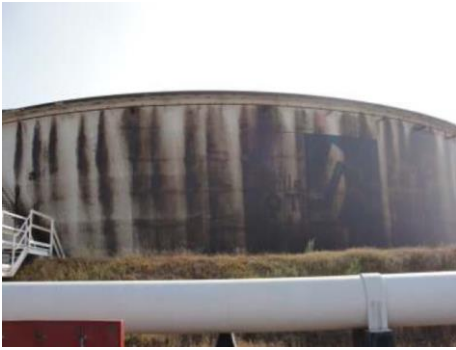
Figure 5. Tank T-6020 with spilled oil. El Maule earthquake 2010.

At the time of the earthquake were two tanks filling height leaving low freeboard, so the "crude oil" spilled in about 270° around the perimeter of these tanks. One of the floating roof was not damaged and the other had some damage on the pontoons. There were no fire tanks. Figure 5 show the T-6020 tank having 67m in diameter by 14.6m height, floating roof designed with the provisions of API650-E with seismic zone 4 and importance factor 1.0. At the time of the earthquake the tank was filled with a height of 13.7m, the convective period was approximately 11sec, which considerably exceeds the range of periods spectra recorded for 2010. Using quake recorded value of $PGA = 0.4\text{ g}$, the provisions of API605-E and a range of convective periods of 4 to 8sec, values tidal wave of 1.0 to 2.1m is obtained approximately. Figure 6 shows the tank T-6030 of 67m in diameter and 14.63m of high, with floating roof, built in 1995 according to the provisions of API650-E eighth edition, considering seismic zone 4 and coefficient of importance 1. This tank present a (lateral spreading) settlement 54mm due to the soil liquefaction. The earthquake struck the tank with a capacity of 25 percent full fluid. Despite the above, bottom plates are deformed due to settling for soil liquefaction. This effect caused the rupture of the fillet welds on the bottom plates.

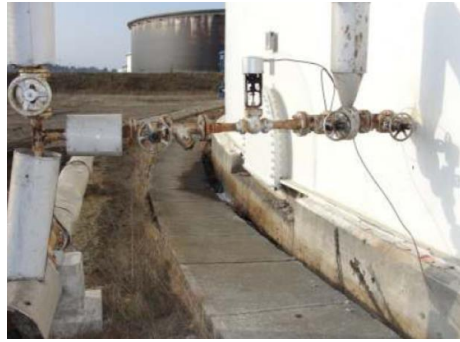
Figure 6. Tank T-6030. With tilt due to liquefaction soil lateral spreading. 2010 El Maule earthquake.

This case is very interesting since despite foundation soil was improved, seismic liquefaction was developed, similar the observed behaviour in Tohoku 2011 earthquake (Zama et al. 2012). In this earthquake, slip phenomenon was not observed due to liquefaction that ground functioned as "seismic isolator". In Figure 7 shown the two main asperities of the El Maule, Chile 2010 earthquake. The sliding of the south asperity near Concepción where ENAP Refinery is located was about 10 meters. Figure 8 shown the GPS horizontal coseismic displacement after the earthquake of 303.9 centimeters in Concepción where ENAP Refinery was located. This large horizontal coseismic no vibratory displacement of the coast are characteristic of the subduction mega earthquakes, which with the simultaneous large vertical acceleration can induce large horizontal tanks displacements such the 1.524 meters indicated by Rinne (1967) for Alaska mega earthquake shown in Figure 1.
