## ANALYSIS OF STEEL TANKS IN CHILE SUBDUCTION EARTHQUAKES

### **Abstract**

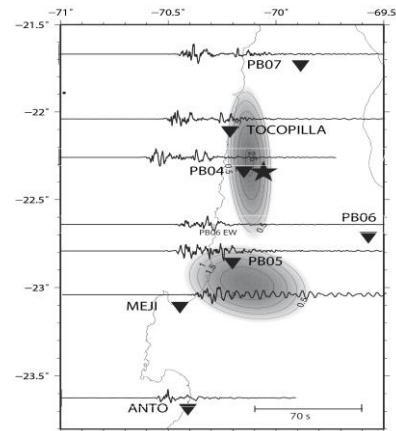
Figure 2. Tocopilla 2007, Chile earthquake, two asperities identified in northern Chile near of Mejillones city [19].

In Figure 2 are shown the mainly plate asperities by effect of Tocopilla 2007 earthquake showing displacement larger than 0.8 meters in Tocopilla (sulfuric acid plant) zone, similar to 1985 Central Chile earthquake. One tank was located at the south asperity near Mejillones, suffering horizontal displacement, which in larger magnitude earthquake could be about 1 meter.

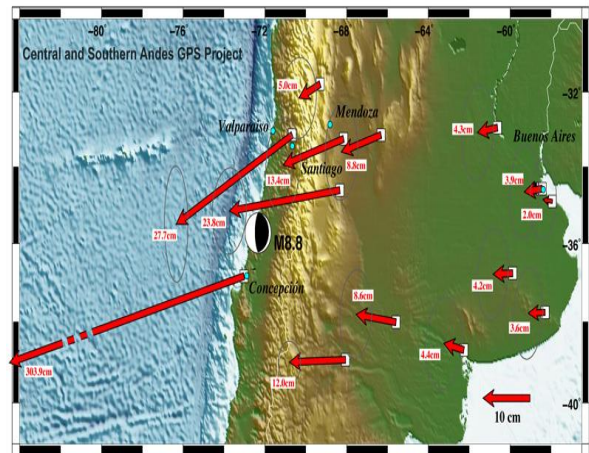
Figure 4. GPS coseismic horizontal displacement after 2010 El Maule earthquake showing 303.9 centimeters at the coast of Concepción, close to ENAP Refinery. [[https://www.soest.hawaii.edu/soest\\_web/soest.news\\_chile\\_feb2010\\_eq.htm](https://www.soest.hawaii.edu/soest_web/soest.news_chile_feb2010_eq.htm)].

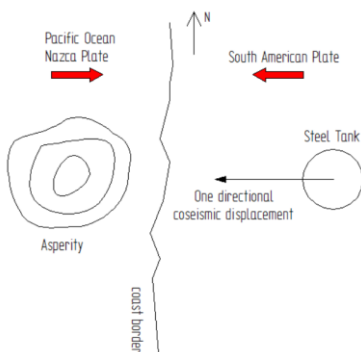
Figure 9. Effects of asperities in tanks in coast subduction zones.

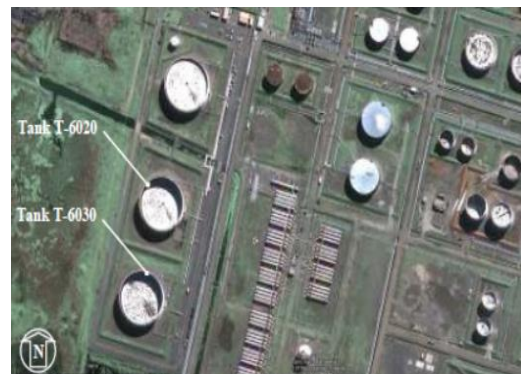
Figure 10. El Maule 2010, Chile earthquake, view of western area at ENAP Bio Bio Oil refinery.

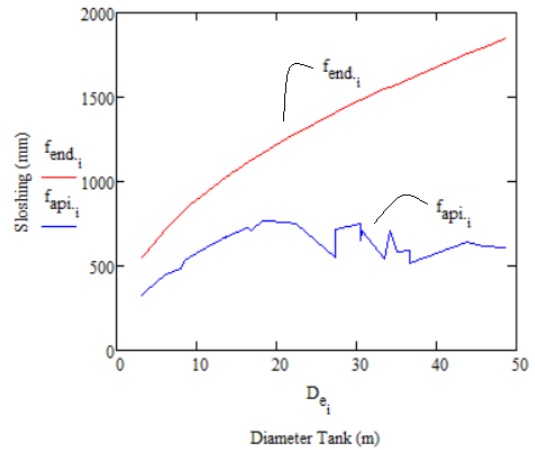
Of 51 tanks analyzed located in areas of subductive interplate earthquakes: Chile 1985, 2007 and 2010, plus Alaska 1964, the Figure 12 shows the important differences for estimate the wave height /freeboard according to usual methods in Chile practice, therefore, it is recommended to investigate this phenomena and calculation methodologies especially for mechanical anchored tanks. Considering the fill heights of these tanks for 1985 Chile earthquake, the vibration periods for the convective mode are between 2 and 9 seconds (Figure 13), being special attention over 7 seconds since according to the displacement spectra of 2010 Chile earthquake, values greater than 20 cm were reached (Figure 14).

Figure 12. Sloshing wave calculated according to some codes used in the Chilean practice.  $f_{end}$  (Endesa standard),  $f_{api}$  (API650 Appendix E), both in mm.

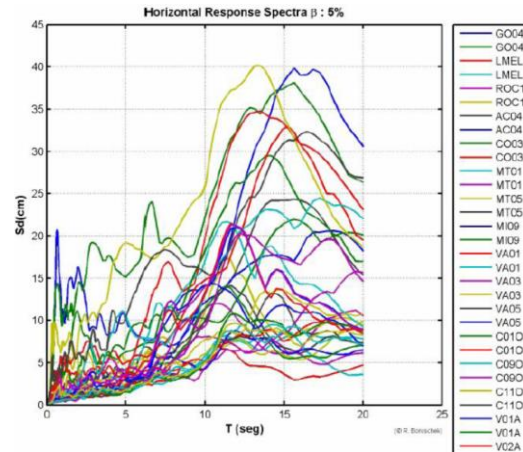
Figure 14. Horizontal displacement response spectra, subductive interplate Chile earthquake, 2015 Illapel ( $M_w=8.4$ ). Boroschek [25].

It should be noted that displacement registers shown by displacement spectra in Figure 14 refer to vibratory motions, whereas the formula (1) and the sloshing of Figure 16 shows an inertial behavior in the mentioned coseismic direction. Considering this formula, anchors of tanks will be required in some cases despite API 650-E recommendation in order to avoid damage in bottom plates as well as piping, in addition to reducing the risk of buckling of shell. The sliding also produce seismic forces not consider in API650-E and other design codes for unanchored tanks. It must keep in mind that the small sliding has produced failure in bottom plates. Table 3 indicate sliding (S) of tanks in coast areas of subduction earthquakes. In 2007 Tocopilla Chile earthquake, the tank located on acid plant in Mejillones city, was detected a horizontal sliding between 80 to 100mm in the perpendicular direction of the coast and corresponding to convergence direction of subducted Nazca plate. According to the orientation the tank indicated in Figure 15 in perpendicular direction to the coastline besides the buckling of shell showing in Figure 6, explains the influence of the earthquake directivity. For the 2010 Chile earthquake Figure 10 shows that the tanks are oriented in direction N-S, on the other hand, Figure 16 shows that the central tank had slosh in W-E direction perpendicular to the coastline, similar to the above mentioned case for the earthquake 2007, confirming the influence of the coseismic directivity of the subductive Chilean earthquake. This effect is incident on the seismic response of tanks with a predominant the convective mass. In both cases the tanks were self-anchored, so it is important to consider a possible horizontal sliding in future earthquakes for tanks located in subductive zones near of asperities and assess the application of the equation (1). Figure 17 shows some tanks located in a gas plant in San Vicente port, tank on the west side on Figure 18 had an inclination of a one-degree perpendicular to the coastline, confirming once again that Chilean coast earthquakes dominated the directivity in the direction of subduction. The tank was built in 1968, it had height dimensions of 11.6m in diameter and 12 meters, and was full during the 2010 Chile earthquake.

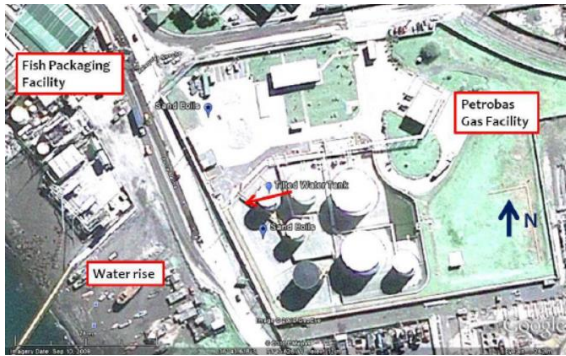
Figure 17. Plan view of the San Vicente Port gas facility, 2010 Chile earthquake, red arrow indicates the earthquake directivity.
