BACKWARD SEISMIC ANALYSIS OF STEEL TANKS

Patricio A. Pineda* and G. Rodolfo Saragoni*

* University of Chile, Santiago, Chile
 e-mails: patricio.pineda@ing.uchile.cl, rsaragon@ing.uchile.cl

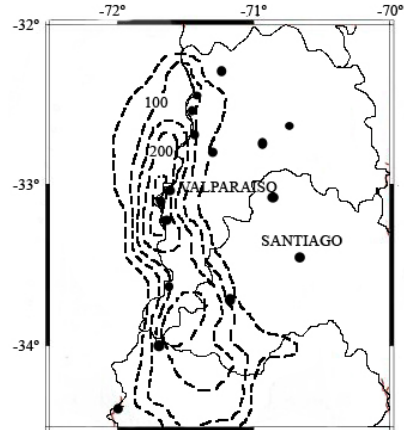
The corresponding two asperities of this subduction earthquake are shown in Figure 2. The asperity, close Valparaiso, Con Con, where ENAP Refinery is located shown horizontal displacement of the plate of more than 2.0 meters.

Figure 2. Central Chile 1985 earthquake. At least two large zones of asperities (modified from Barrientos (1988)).

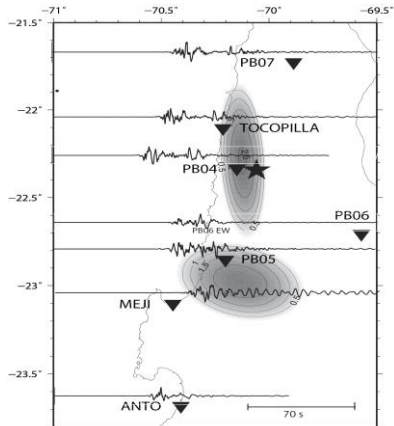
Figure 4. North Chile Tocopilla 2007 earthquake. At least two large zones of asperities. South asperity at Mejillones location of the TK-201 tank (Peyrat et al. (2009)).

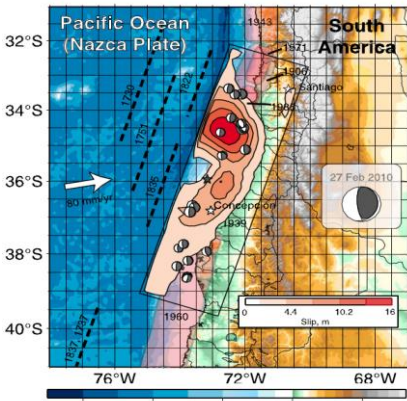
Figure 7. Asperities of El Maule 2010, Chile $M=8.8$ earthquake. South asperity near Concepcion indicate sliding of 10 meters. (Lay et al. (2010)).

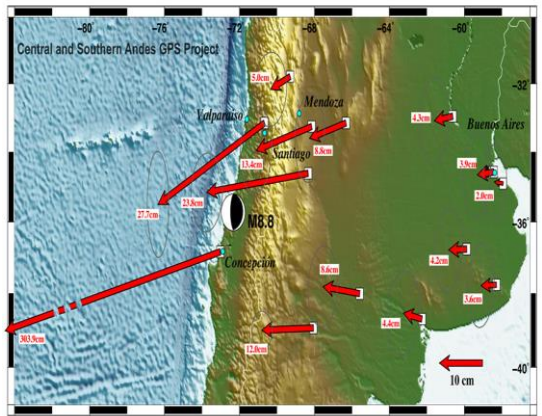
Figure 8. GPS coseismic horizontal displacement after 2010 El Maule earthquake showing 303.9 centimetres at the coast of Concepción, where ENAP Refinery was located. (https://www.soest.hawaii.edu/soest_web/soest.news_chile_fe_b2010_eq.htm.)
